**TERRACE LAKE DAM  
JACKSON COUNTY, MISSOURI  
MO 20167**

## **PHASE 1 INSPECTION REPORT NATIONAL DAM SAFETY PROGRAM**

**AUGUST 1978**

PHASE I INSPECTION REPORT

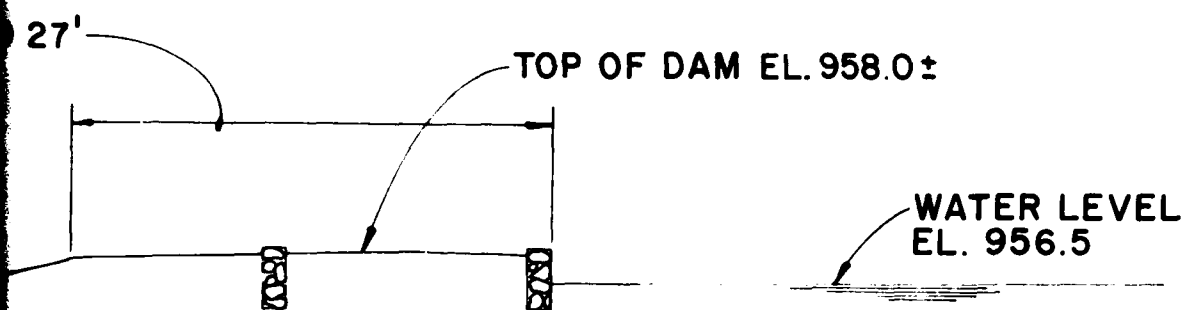
TERRACE LAKE  
TYPICAL SECTION

VARIES FROM 16' TO 27'

SLOPE 2 1  
APPROX.

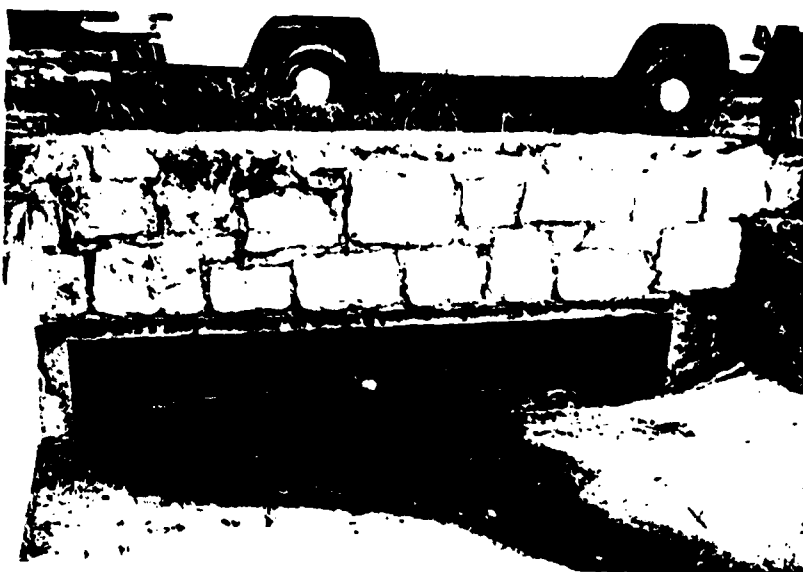
c. Appurtenant Structures. The spillway is a 10.2 by 1.6 feet box culvert with a concrete approach apron beginning 10 feet upstream of the spillway. The spillway appeared in good condition other than some minor spalling. The spillway discharges into a broken limestone channel which is severely overgrown with weeds and small trees. Erosion was observed behind the left spillway training wall, but did not appear serious. Seepage of less than 5 gpm was observed in the discharge channel about 25 feet downstream from the axis of the dam.

PHOTO 3      SPILLWAY (LOOKING DOWNSTREAM)
